*Post Occupancy Evaluation of social housing designed and built to Code for Sustainable Homes Levels 3, 4 and 5*

**Abstract**

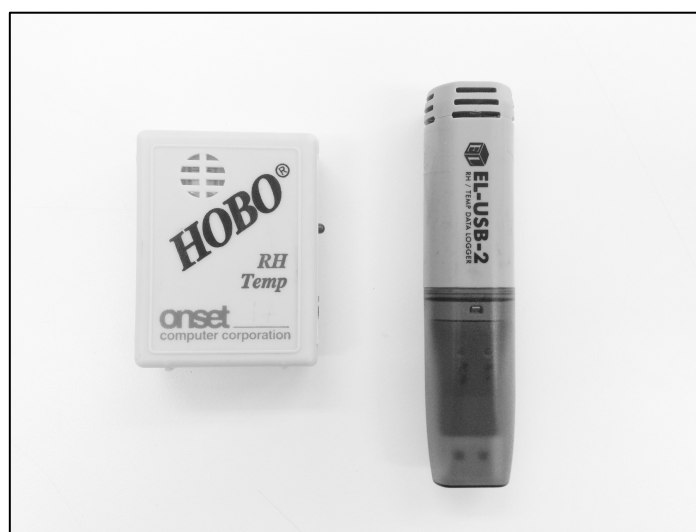
Figure 1: HOBO H8 and LASCAR EL-USB-2 dataloggers

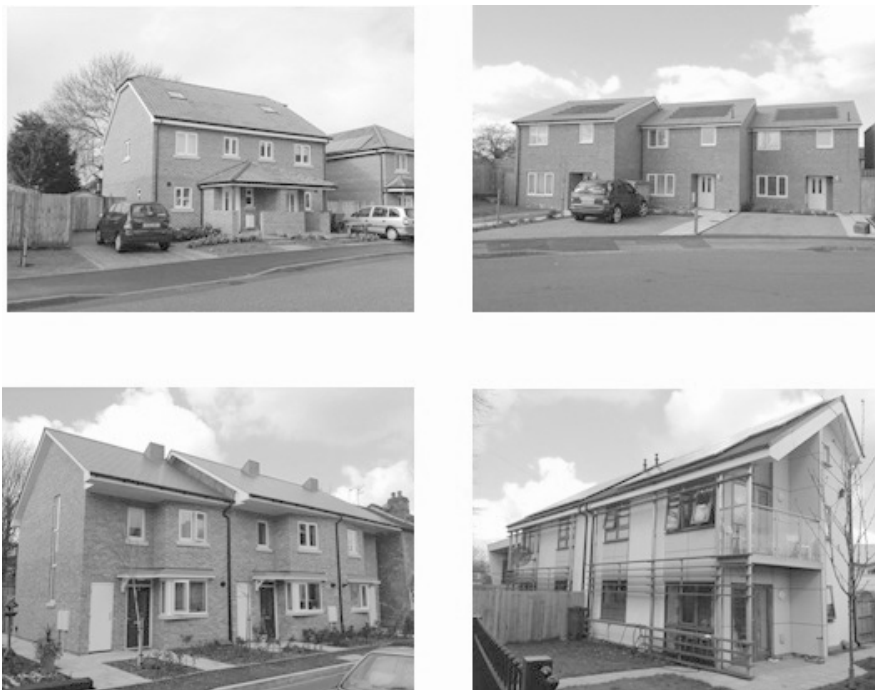
Figure 2: The dwellings, clockwise from top left, 39OB (Code level 3); 138NG / 139NG (Code level 4); 94SR/ 96SR (Code level 5); 249MR / 249aMR (Code level 5)

To ensure anonymity, the dwellings are given simple reference numbers and these are used throughout this paper. The table shows the basic dwelling unit configuration in terms of number of bedrooms and occupants, the floor area and the CfSH level. It also describes the fabric and building servicing strategy for each dwelling giving details of the technology installed into each home. Figure 2 shows the four dwelling types tested in this study.
